# ACR Guidance Document on MR Safe Practices: 2013

**Key Words:** MR safety; MR; MR safe practices  
**J. Magn. Reson. Imaging 2013;37:501–530.**  
 © 2013 Wiley Periodicals, Inc.

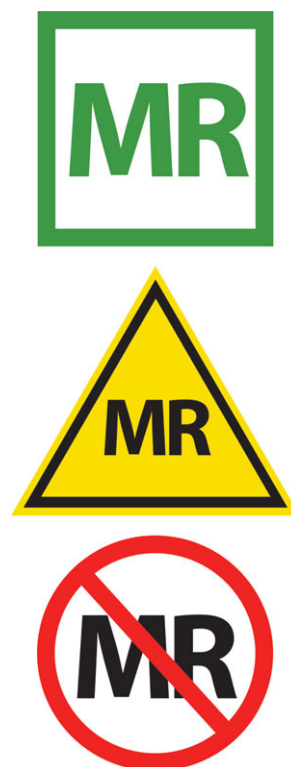
**Figure 2.** U.S. Food and Drug Administration labeling criteria (developed by ASTM [American Society for Testing and Materials] International) for portable objects taken into Zone IV. Square green “MR safe” label is for wholly nonmetallic objects, triangular yellow label is for objects with “MR conditional” rating, and round red label is for “MR unsafe” objects.

- a. All portable metallic or partially metallic devices that are on or external to the patient (e.g., oxygen cylinders) are to be positively identified in writing as MR Unsafe or, alternatively, MR Safe or MR Conditional in the MR environment before permitting them into Zone III Figure 2. For all device or object screening, verification and positive identification should be in writing. Examples of devices that need to be positively identified include fire extinguishers, oxygen tanks and aneurysm clips.

erly identified and appropriately labeled using the current FDA labeling criteria developed by ASTM International in standard ASTM F2503 (<http://www.astm.org>). Those items which are wholly, nonmetallic should be identified with a square green “MR Safe” label. Items which are clearly ferromagnetic should be identified as “MR Unsafe” and labeled appropriately with the corresponding round red label. Objects with an MR Conditional rating should be affixed with a triangular yellow MR Conditional label before being brought into the scan room/Zone IV.
